**National  
Transportation  
Safety Board**

# Investigative Update of Battery Fire Japan Airlines B-787 - Jan 7, 2013

*January 24, 2013*

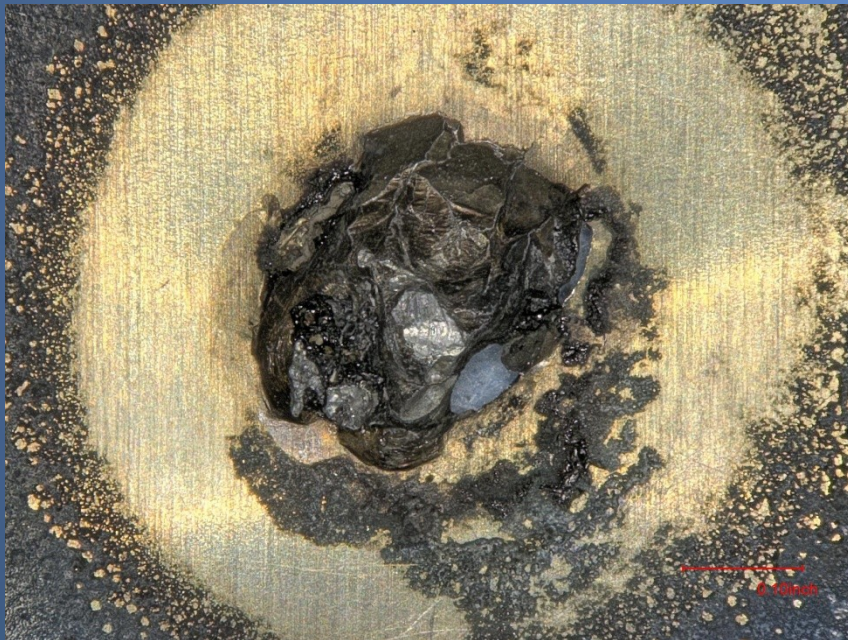
Viewed From Outside  
(Post-clean)

# Battery Case “Anomaly”

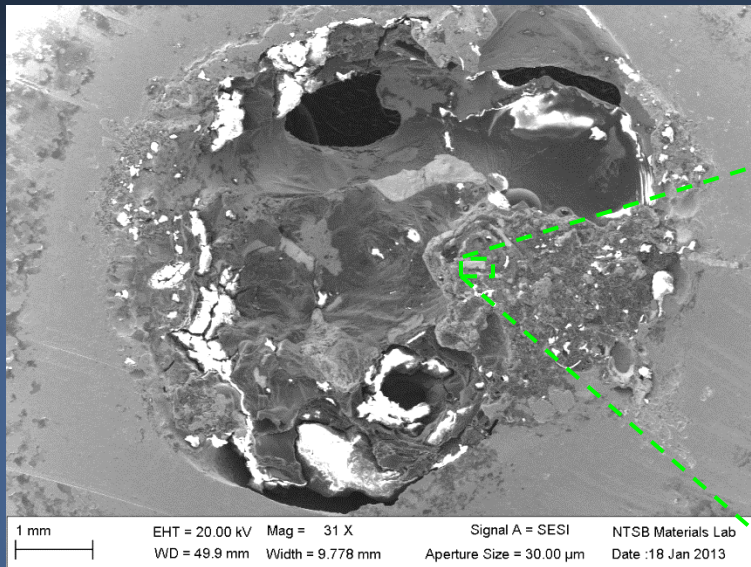
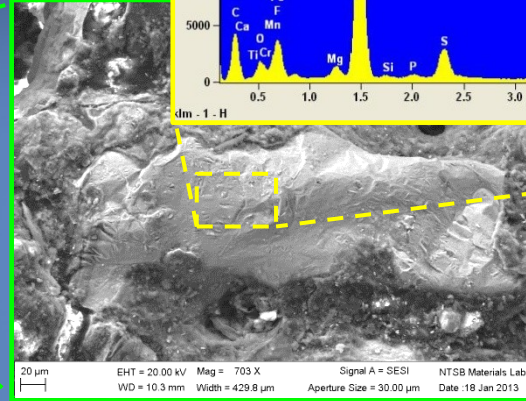
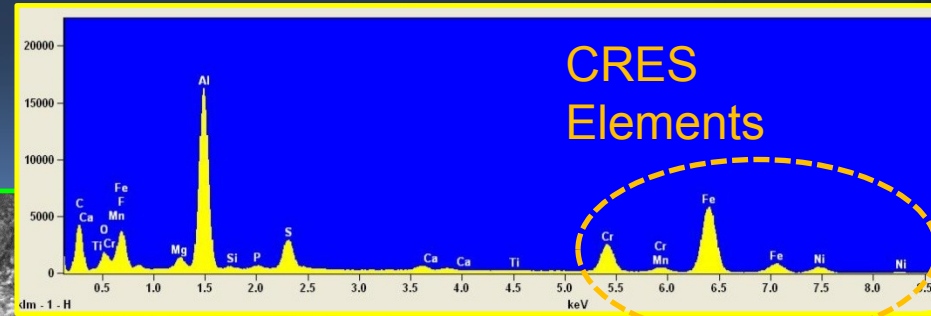
# Microscopic Inspection – Inside

- Finding: electrical arc between battery cell and inside of battery case
- Not believed to be initiating event
